MOUSAM RIVER BASIN
SANFORD, MAINE

MILL STREET DAM
ME-00273

PHASE I INSPECTION REPORT
NATIONAL DAM INSPECTION PROGRAM

AUGUST 1981

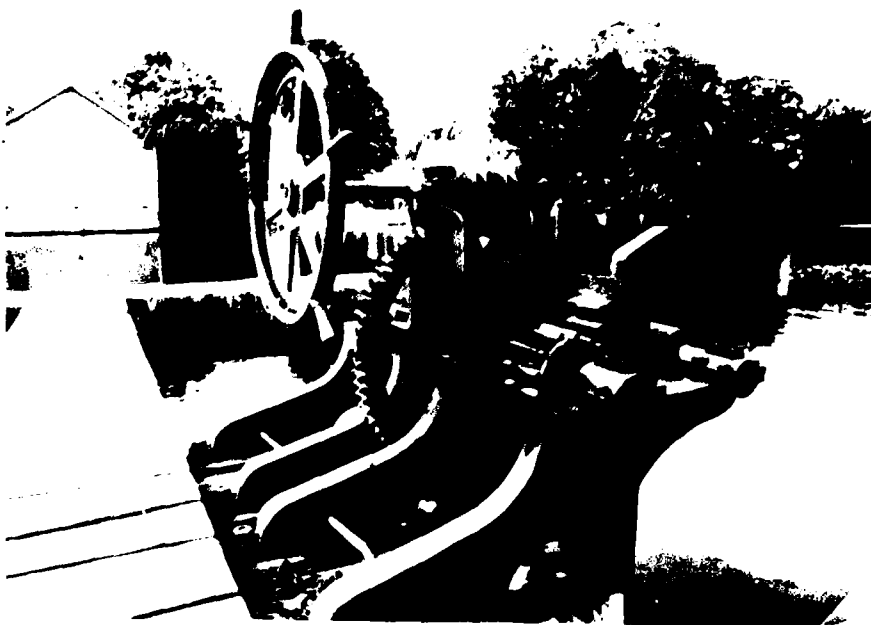
6

C O N T R O L G A T E M E C H A N I S M
